Re: Seventh and Allen Equities
Loss Location: 602-618 North Seventh Street
Allentown, PA 18101
Sprinkler Water Loss
Hartford Claim Number: CP8457355
Our File Number: 5621

On or about March 4, 2009, a sprinkler activated on the third floor at the above-referenced loss location. The sprinkler reportedly activated due to a frozen pipe. Water from the activated sprinkler caused damaged throughout 602-618 N. Seventh Street, Allentown, PA 18101. Plick and Associates, Forensic Engineers was requested to investigate the cause of the sprinkler activation.

Plick and Associates, Forensic Engineers

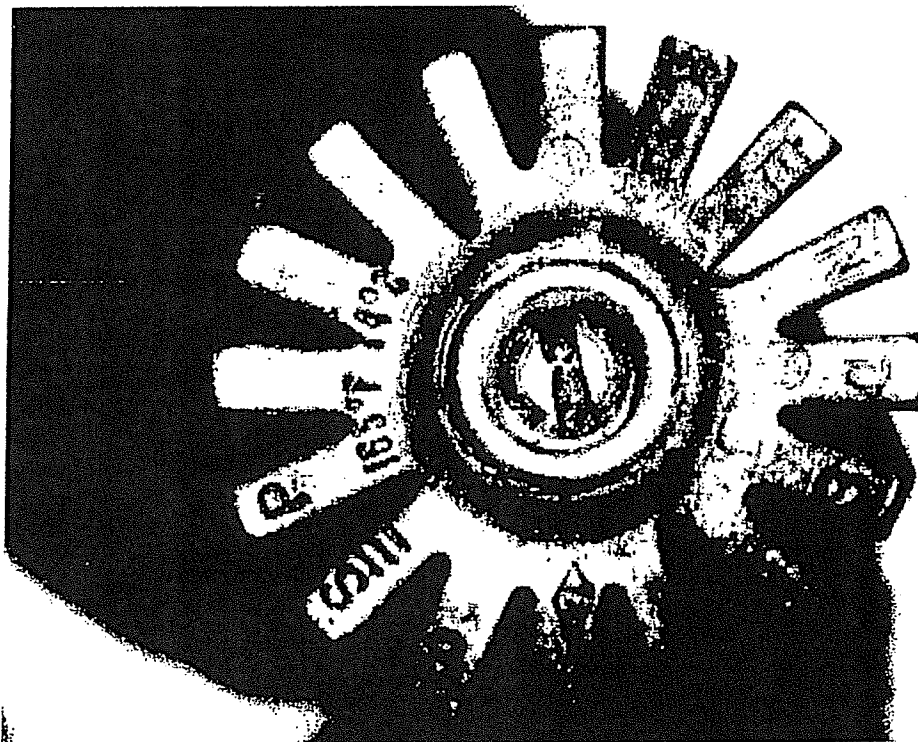
The subject activated sprinkler was replaced prior to my inspection. The subject sprinkler was retained and presented to me by Rite-Aid employees. The sprinkler is a Viking, Viking Corporation, 210 N. Industrial Park Drive, Hastings, Michigan 49058, SSP 165°F. pendant-type sprinkler. The sprinkler did not appear to have any observable damage, indicating an outside force, such as something striking the outside of the sprinkler, activated the sprinkler (Photos 1 & 2).

PHOTO 2 – Subject sprinkler

Based upon the preliminary results of my investigation, I have concluded, the activated/discharged sprinkler and subsequent water loss was caused by lack of heat on the second and third floors. It is also my opinion if the heat were present the loss would not have occurred.

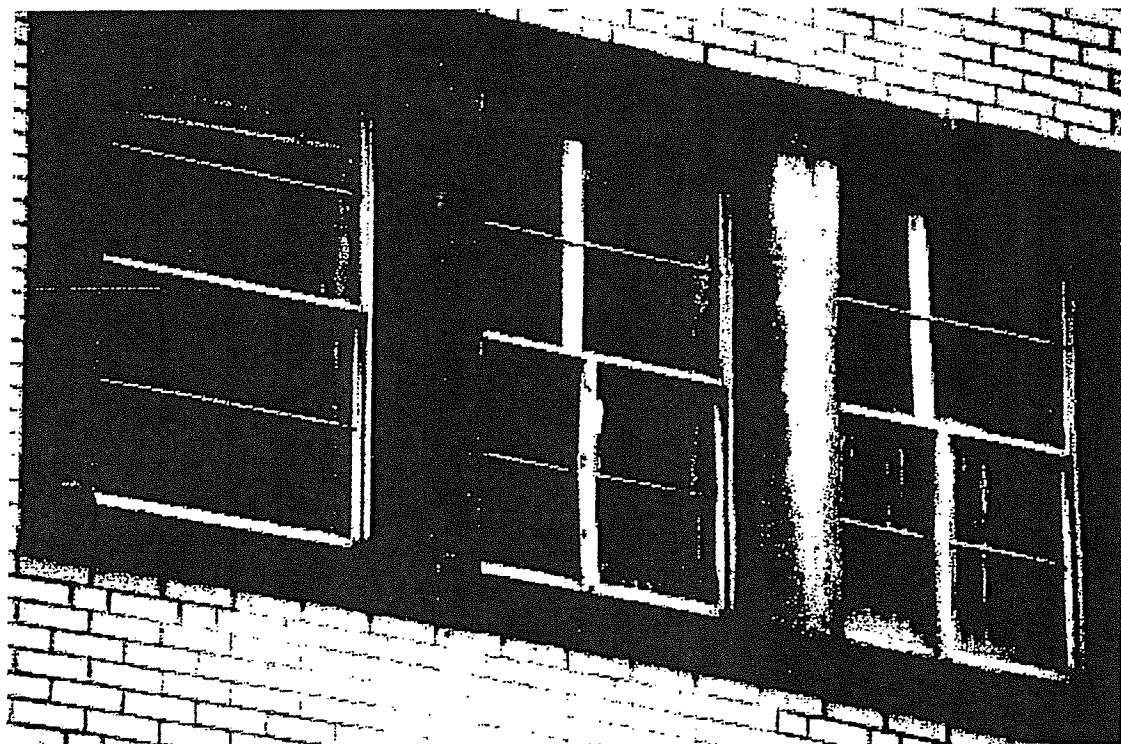
In addition, you informed me that several windows may have been open at the time of loss. There are currently wood strips wedged in between the window frames and sill plates of the windows to prevent the windows from opening (Photos 5 & 6).

PHOTO 6 – Exterior view of windows
